SCANNING ELECTRON MICROSCOPY OF FRACTURE  
SURFACES OF CARBON COMPOSITE MATERIALS

NLR TR 76035 U

## SCANNING ELECTRON MICROSCOPY OF FRACTURE SURFACES OF CARBON COMPOSITE MATERIALS

W.G.J. 't HART

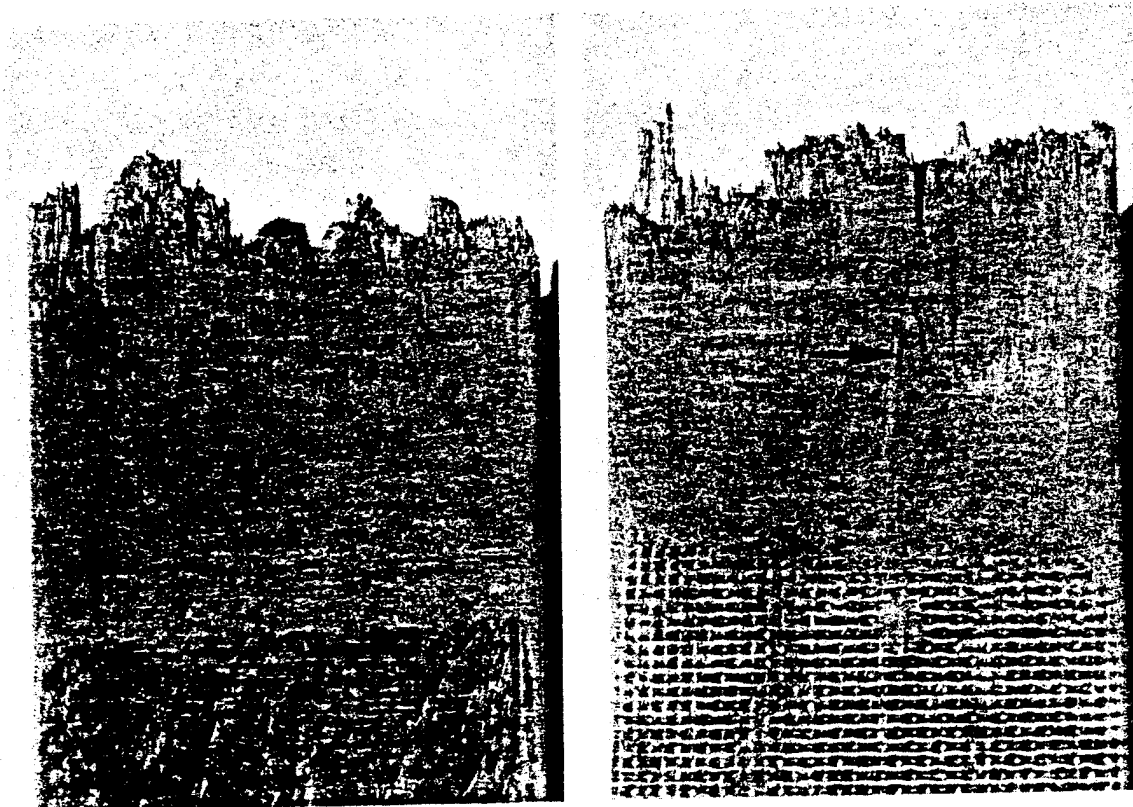
Low magnification photographs of a tensile fracture are shown in figure 6. The specimen was "waisted" in the thickness direction in order to prevent failure in the grips. Failure occurred in the thinnest section. In one part of the specimen delamination occurred, indicating that the waisting procedure introduced stress concentrations leading to shear stresses exceeding the interlaminar shear strength. Figure 6 shows a rather straight fracture surface, indicating a good interface strength (although a straight fracture surface is also partly caused by the waisting procedure).

Figure 6 Fracture surfaces of a "waisted" tensile specimen

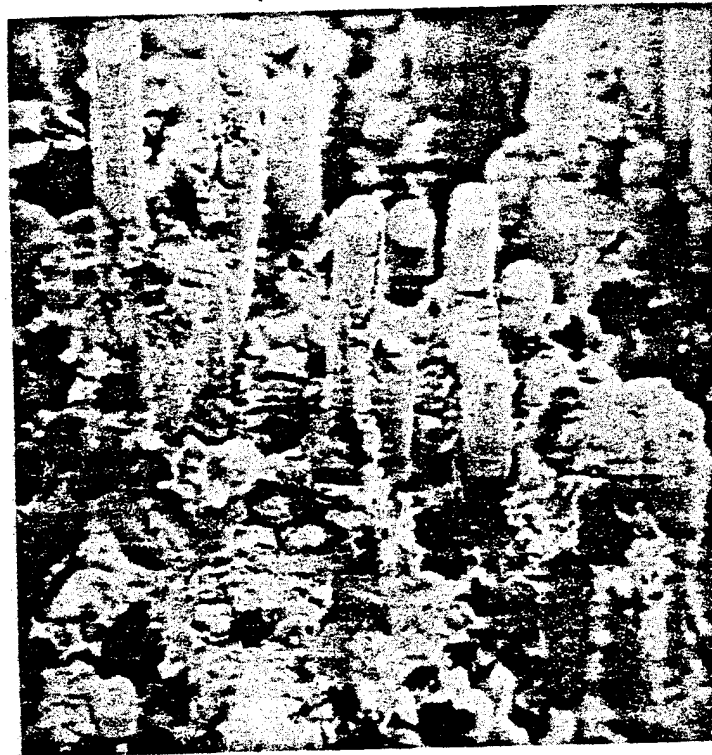
640 X

Figure 7 presents an SEM photograph of the fracture. There is only

slight fibre pull-out. Clusters of fibres have been broken with resin adhering to the fibres. This indicates that there is a strong interface since clusters of fibres then react as integral units and fracture will initiate from weak planes rather than from each individual fibre.

Figure 7 SEM photograph of the fracture surface shown in figure 6

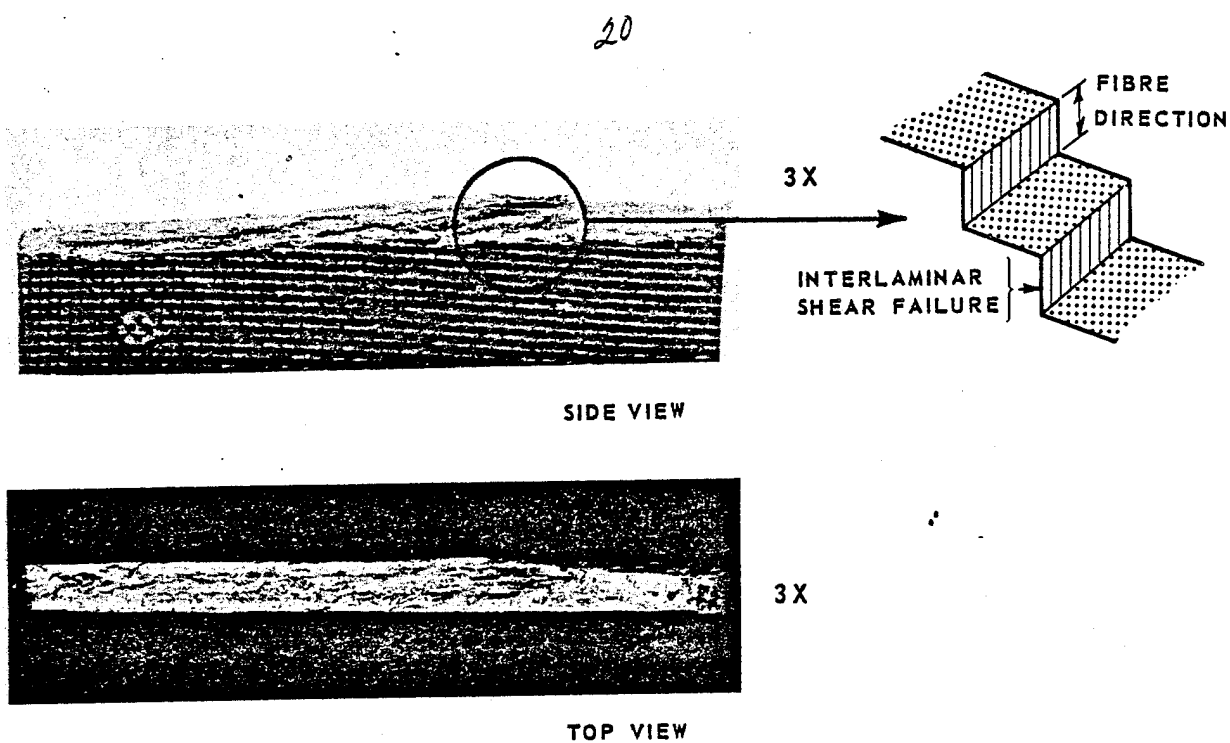
The macroscopic appearance of a compressive fracture of a carbon/epoxy specimen is a relatively smooth fracture surface at an angle of  $45$  to  $60^\circ$  with the loading direction (Fig. 8 and 9). During the fracture process interlaminar cracks can be formed and local buckling can occur, resulting in an irregular, stepped fracture surface (Fig. 9).

Figure 9 Compressive fracture surfaces of a carbon/epoxy specimen

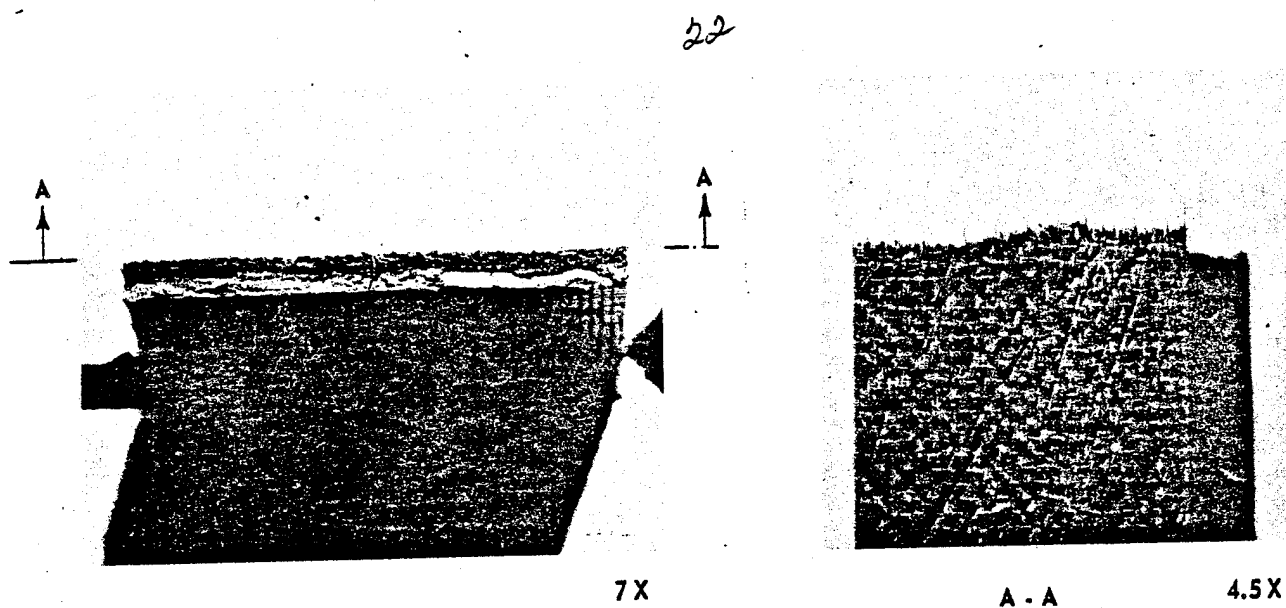
Considering the fracture surface of the investigated specimen at a low magnification, smooth and rough areas are observed (Fig. 12). The smooth area is the result of a compressive failure. The fibrous appearance of the other part indicates fibre pull-out under tensile stresses.

From the low magnification photographs it can be concluded that fracture was the result of flexure rather than shear. However, an SEM

Figure 12 Fracture surface of a three point bend specimen

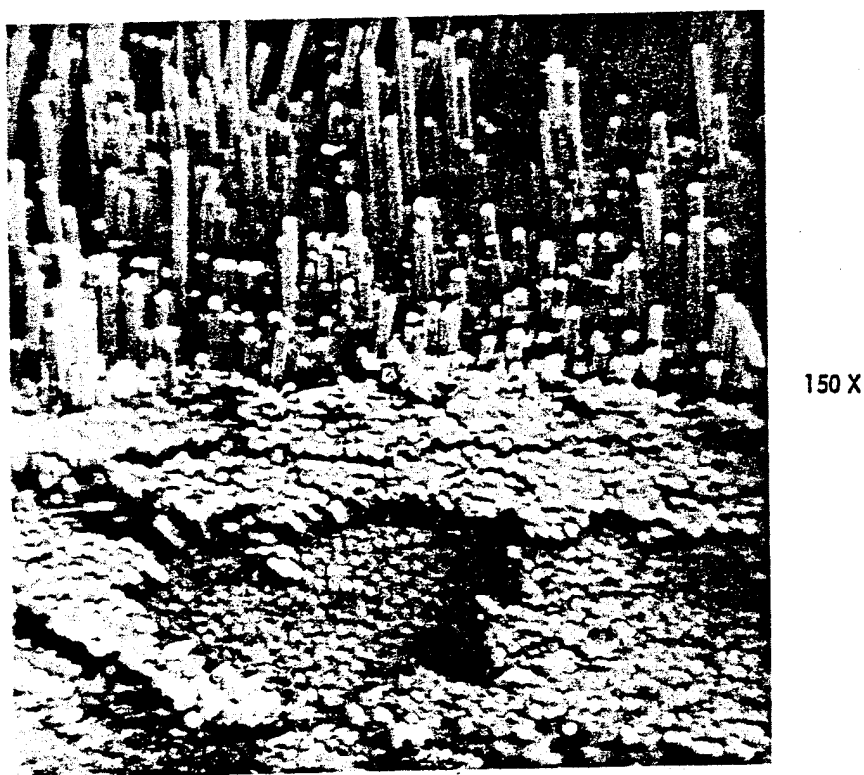
photograph taken from the transition zone also shows interlaminar shear cracks, developed at the neutral plane, figure 13. Away from the neutral plane less shear cracks are observed, figure 14, 15. The flexural failure mode has therefore probably been initiated by shear forces.

The tensile part of this beam specimen shows a considerable fibre pull-out, figure 13. No resin parts adhere to the broken fibres and clusters of fibres have not broken as integral units. Thus, the interface bond was not so good as the interface bond in the tensile specimen discussed previously (compare Fig. 7 and Fig. 13).

Figure 13 SEM photograph of the fracture surface shown in figure 12, at the location of the "neutral plane" (150x)

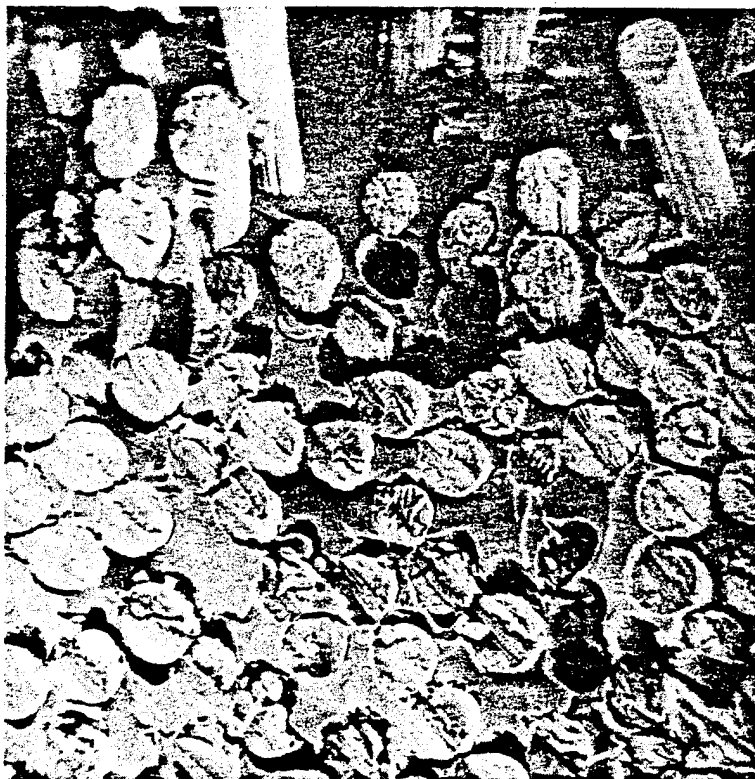
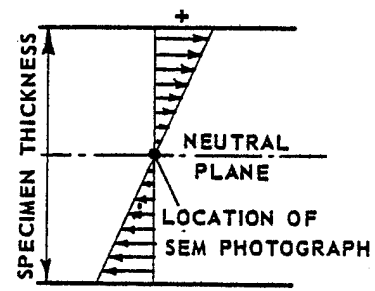
Fig. 14

Figure 14 to 16 show a large number of fibres failed by microbuckling. The actual loading direction can be derived from the buckling orientation, since buckling of all the fibres occurred in the same direction.

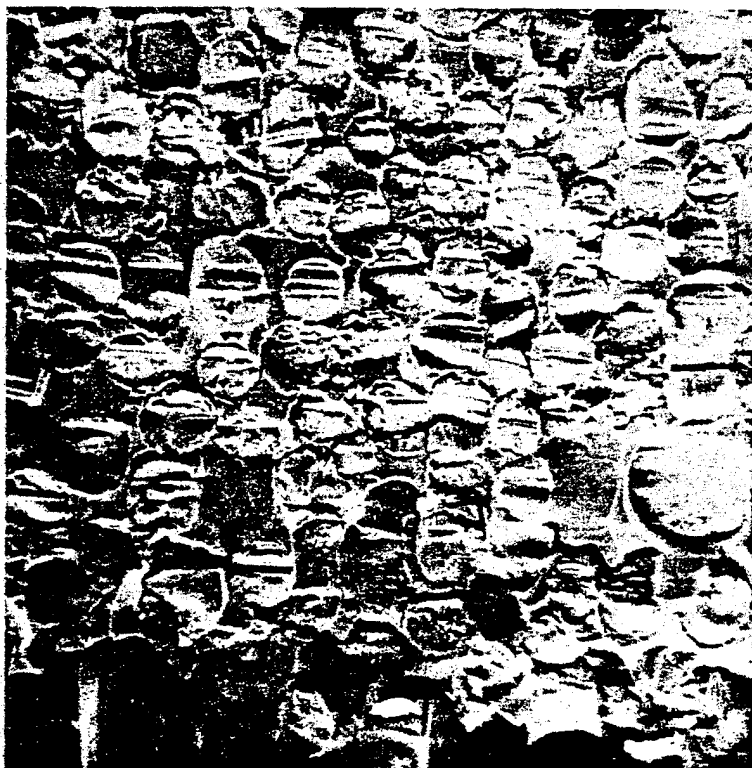
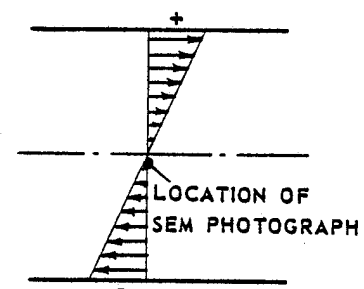
Figure 15 SEM photographs showing interlaminar shear cracks  
(upper figure) and fibre buckling

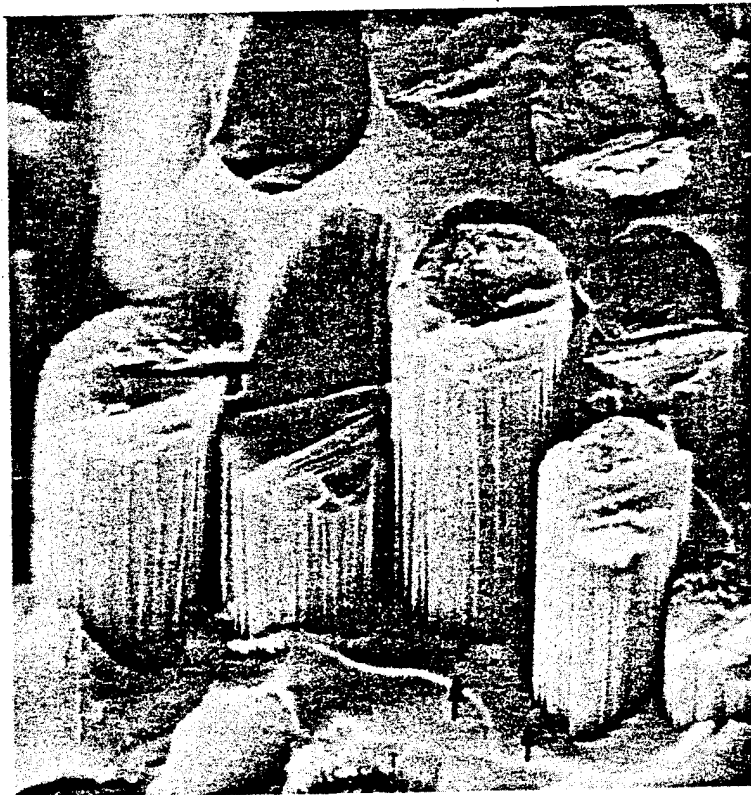
2500 X

From figure 16 it can be seen that surface wetting of the fibres by the resin was very good. At the bottom of some fibres in figure 16, several matrix cracks have initiated in a radial direction. These cracks probably originated at the circumference of fibres under influence of a combination of residual shrinkage stresses in the matrix and additional stresses due to the fracture process. A theoretical consideration of Chamis (Ref. 9) on residual stresses in polymer matrix composites shows that the resin hoop stress might reach  $40 \text{ MNm}^{-2}$ , figure 17. The order of magnitude of the tensile strengths of epoxy resins is 50 to  $100 \text{ MNm}^{-2}$ . The crack orientation is such that no influence on tensile fracture can be expected.

Figure 16 SEM photograph of fibre buckling (2500x)

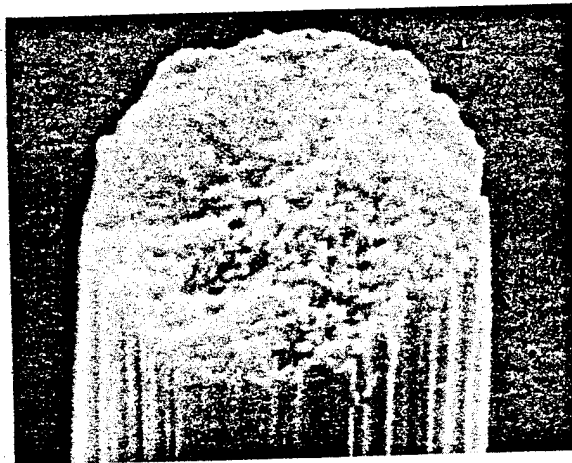
6400 X

Purely tensile fracture surfaces of single fibres are shown in figures 18 and 19. The fracture surface appearance can be related to the theoretical model of the carbon fibre, reference 14, 15. The precursor of most carbon fibres is polyacrylonitrile. The liquid polymer is pressed through a spinneret having 10,000 microscopic holes, and a silvery white string is obtained. In a stretched condition the strings undergo oxidation and carbonization stages. The initial stretching and the shrinkage during processing helps to increase the axial alignment of the polymer molecules. During processing a ladder struct-

A carbon fibre with a diameter of about 8  $\mu\text{m}$  consists of some 100 or more ribbons (fibrils) with a certain degree of ordering to the fibre axis, figure 21. The fibre surface is smooth but the fibrils are visible at high magnifications, e.g. figure 18.

Figure 18 Tensile fracture  
surface

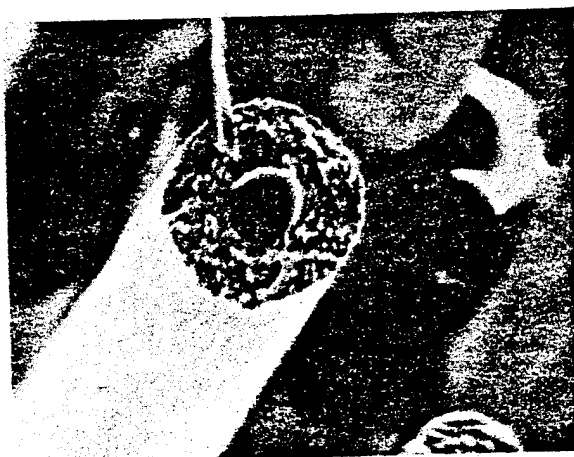
1650 X

Figure 19 shows a peculiar shape for a carbon fibre, namely a hollow fibre. It is not clear whether this exceptional shape is due to the spinning process or is caused by "internal oxidation" of the PAN fibre.

Figure 19 A hollow carbon  
fibre

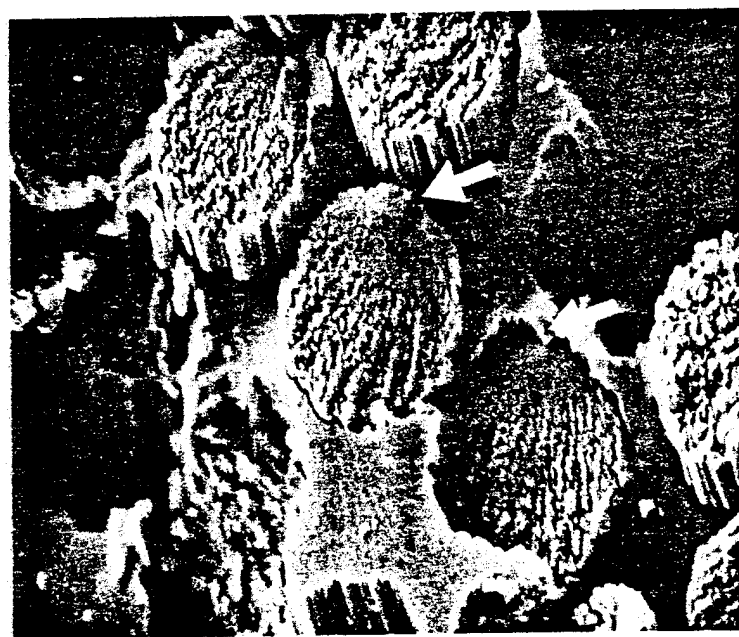
If a carbon fibre is not loaded by a uniform tensile stress, crack initiation may occur at the circumference of the fibre. This is what happened to several fibres shown in figure 22. On the resin fracture surface marks can be observed indicating the crack propagation direction.

Figure 22 Fracture initiation at the edge of a carbon fibre  
(2300x)

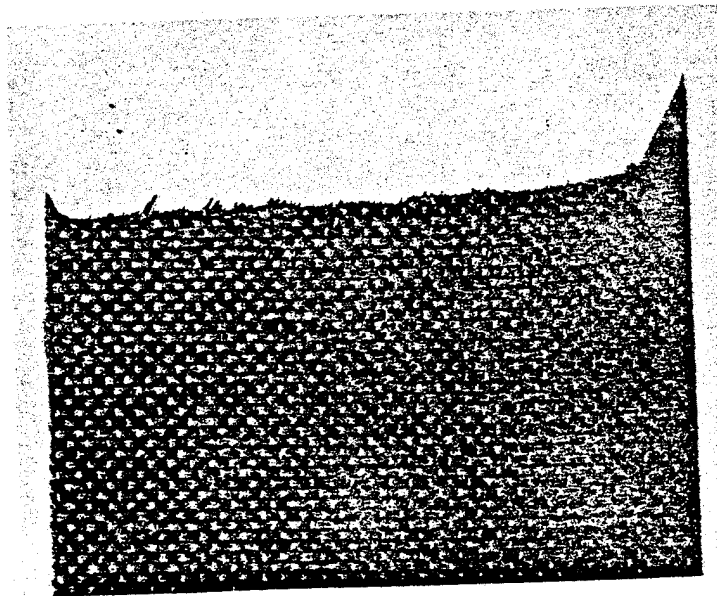
2X

The photographs of cross plied carbon/epoxy fatigue specimens are shown in figures 23 and 24. The specimens have been tested at constant amplitude loading for  $R > 0$ . Fatigue failure initiation started by delamination at the edges of the specimens. Failure occurred after continued delamination.

Figure 23 Fracture surface of a carbon/epoxy specimen tested under fatigue loading

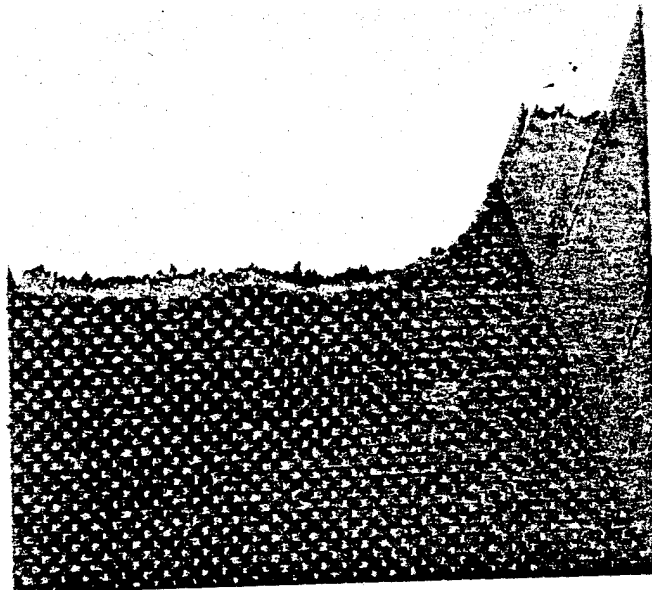
2X

Figure 24 Fracture surface of a carbon/epoxy specimen tested under fatigue loading

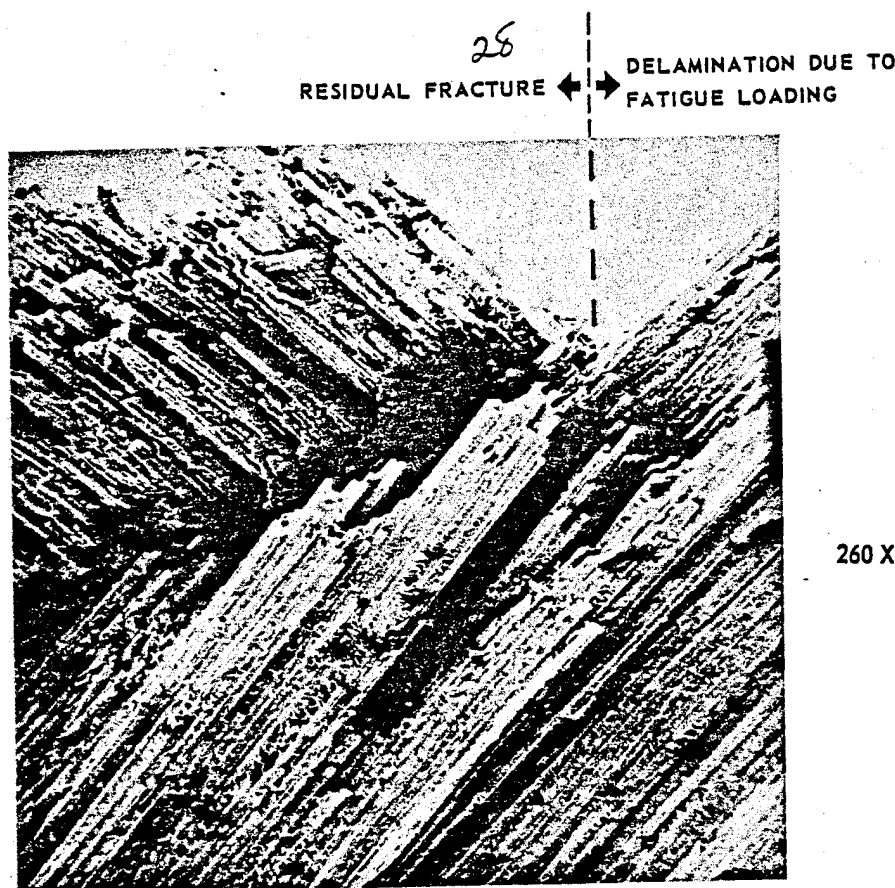
Figure 25 shows the transition of the zone with fatigue damage to that of residual fracture.

Figure 25 Transition of the zone with fatigue damage to that of residual fracture

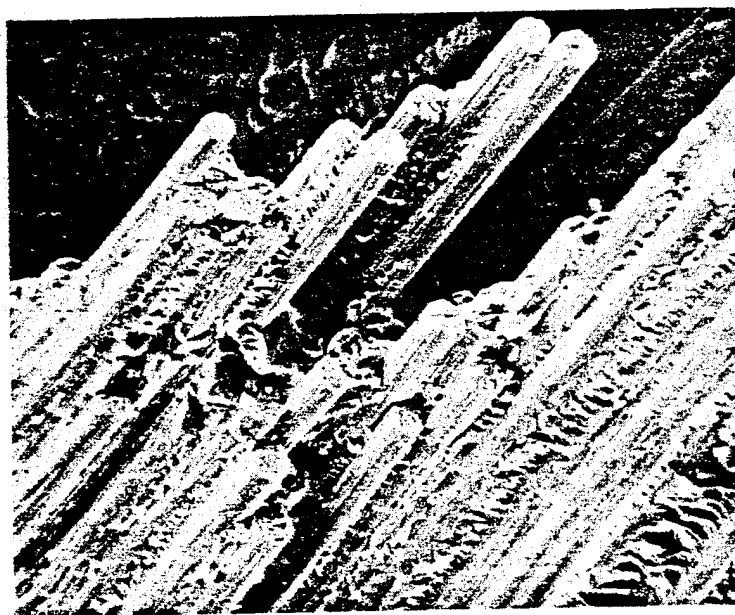
There was a strong interface, since at numerous locations on the overload part of the fracture surface integral units of broken fibres can be observed, figure 26.

Figure 26 SEM photograph showing a good interface bond in the cross plied laminate (650x)

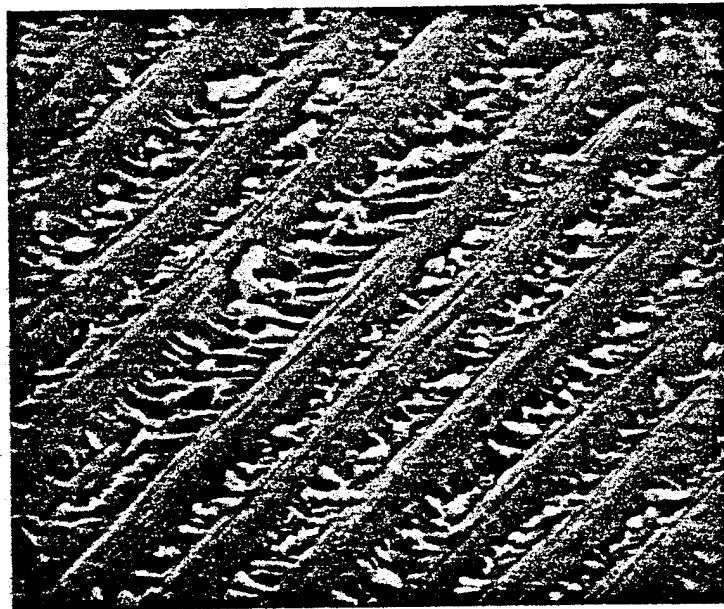
1240 X

Delamination due to fatigue loading results in a different fracture surface appearance in comparison with a delamination fracture surface caused by static loading (cf. Figs. 27, 28).

In figure 27, the fatigue failure, the surface is smooth and no resin particles adhere to the carbon fibres. During fatigue loading partial debonding of the fibre matrix interface probably occurred first, after which the matrix between the fibres failed by decohesion. The laminar shear fracture surface due to static loading, figure 28,

Figure 27 Shear failure by fatigue delamination (1240x)

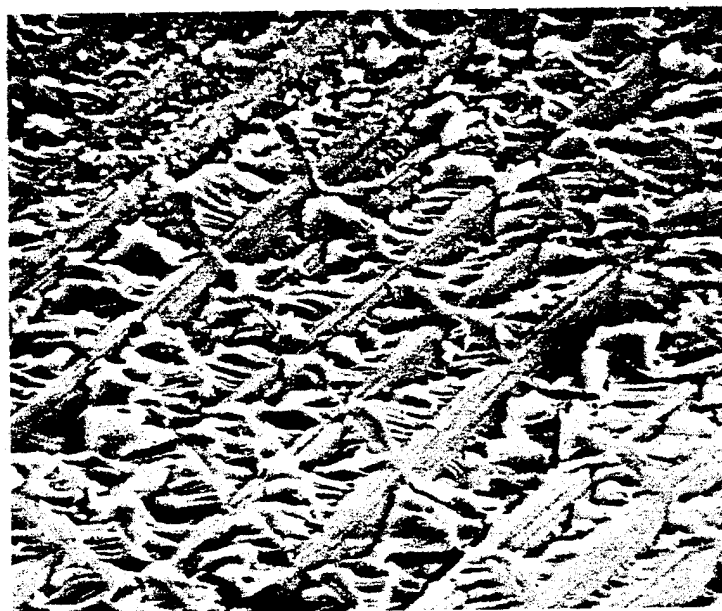
1240 X

is rather rough and interface debonding is less evident. The difference in fracture surface appearance could be caused by the strain-rate dependency of the resin properties.

Figure 28 Shear failure in the residual fracture surface (1240x)
